Field Service Bulletin No. 10

ADC Compact Plus
Type 5146/100

Centricity CR MP3510
Type 5146/200

Problem of Sharp White or Black Lines in Fast Scan Direction

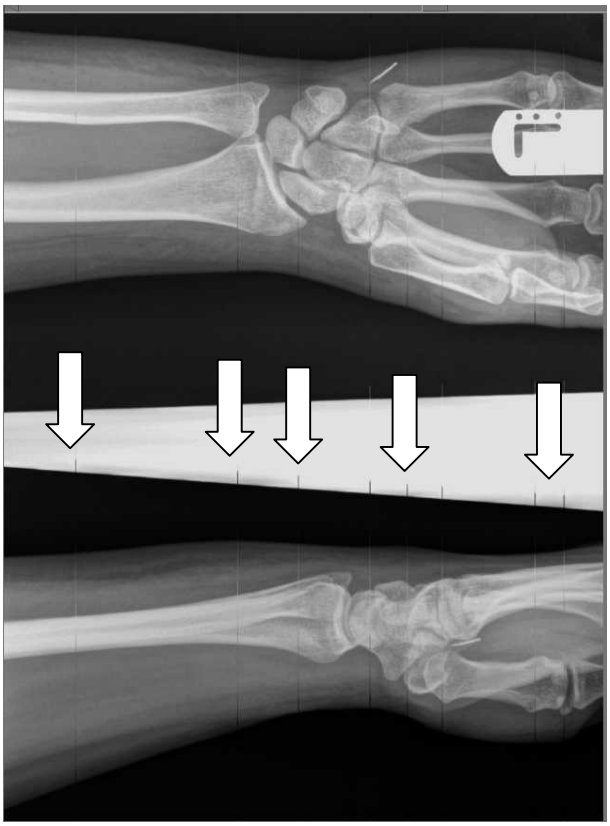
Sporadically sharp white and black lines may occur in fast scan direction.
See image for explanation.

BOL PCB within the optic module (CM+9.5146.2750.0) is considered to cause this problem.

- Contact HE/IMG-GSO
- To prevent from unjustified exchange of optic modules in the field and due to the high costs HE/IMG-GSO will validate every order after artifact image and info counter analysis.
- Place an order in the EVS-System.
- The defective spare parts must be sent back immediately to the address mentioned below as MA4 parts:
